Floodwater Clearance

Identifying the 100-Year Flood Level

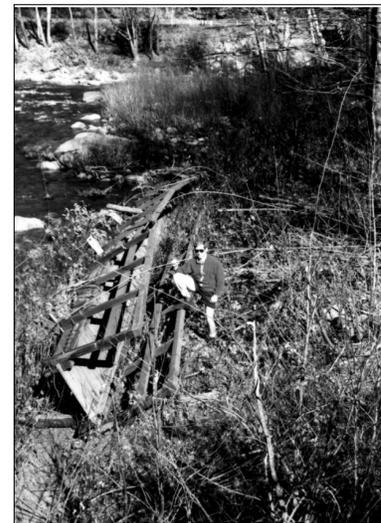
Photo 52. Tibor Latincics and remains of the Hastings Trail Suspension Bridge. *Photo courtesy of Mr. Tibor Latincics.*

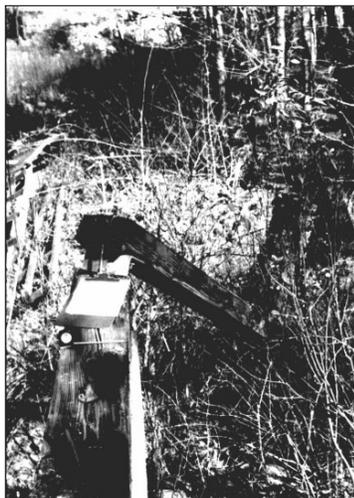
Photo 53. The timber towers were sheared at the base by floodwater driven debris. *Photo courtesy of Mr. Tibor Latincics.*

Mountains. In this case, the floodwaters picked up an old logging bridge and carried it downstream. The Hastings Trail Bridge was a 180-foot suspension bridge with a 17-foot clearance to the normal water level of the Wild River. However, the logging bridge snagged on the low hanging wind guys of the bridge. The impact force and hydrodynamic loads sheared the bridge towers at their base. Twenty-thousand pounds of buried concrete deadmen were plucked out of the soil and flung 200 feet downstream. Proper clearance to floodwater is critical!

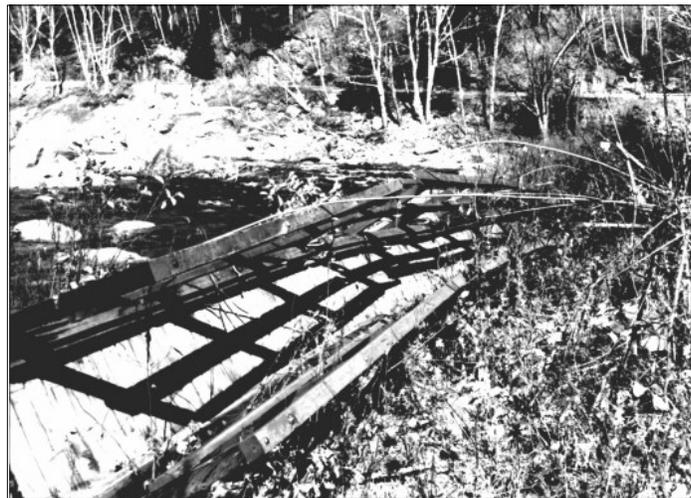
Photo 54. Hastings Bridge walkway remains flung downstream. *Photo courtesy of Mr. Tibor Latincics.*

The Hastings Creek Bridge was reconstructed in the Fall of 1997, to USDA Forest Service specifications. The new 180-foot bridge has a clear travel lane dimension of 5.5 feet to allow snowmobile traffic. There is a paved road directly to the site. The original tower foundations were reused. The replacement cost for the bridge superstructure by a professional contractor was \$142,675.
