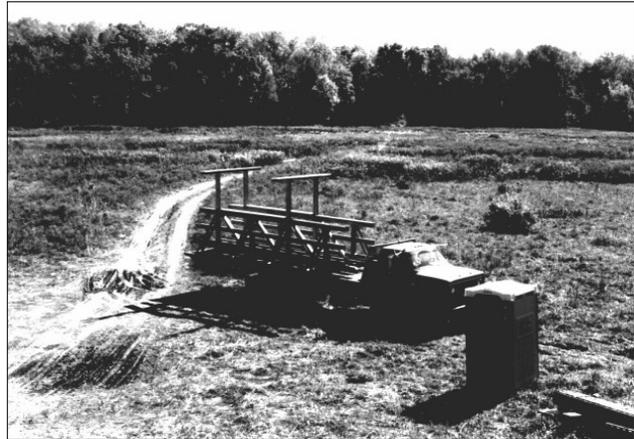
Photo 50. Fabricated bridge sections were trucked to the site by the NJ Forest Fire Service. *Photo courtesy of Mr. Tibor Latincsics.*

As indicated in photos 41-50, the entire bridge walkway, including the joint connections between each section, was prefabricated and assembled in the Wawayanda State Park maintenance yard. The structural integrity of the bridge sections was tested when they were dragged across the parking lot by backhoes. As shown in photo 46, the bridge walkway was set to the 3.5 percent camber it would assume in the air using car jacks in order to layout the joints for the center section. The bridge walkway sections were then loaded on trucks and delivered to the bridge site as indicated in photo 50. By this time it was October, and the hurricane season had commenced; site access had begun to deteriorate significantly.
